# BRAL RESTORATION, LLC

#### Water Leak Investigation Results:

## 2726 West Cortez Condominium Association

**Leak Inspection Report.**

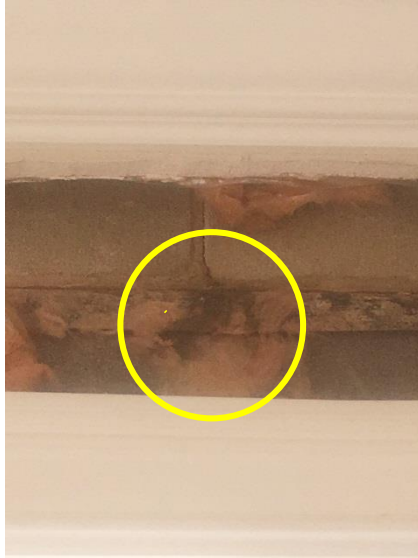
## Location of Interior Water Leak 3<sup>rd</sup> Floor Window Head.

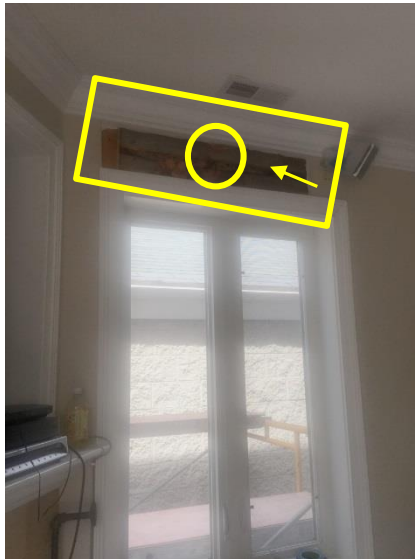
## 3<sup>rd</sup> Floor Window Leak Testing.

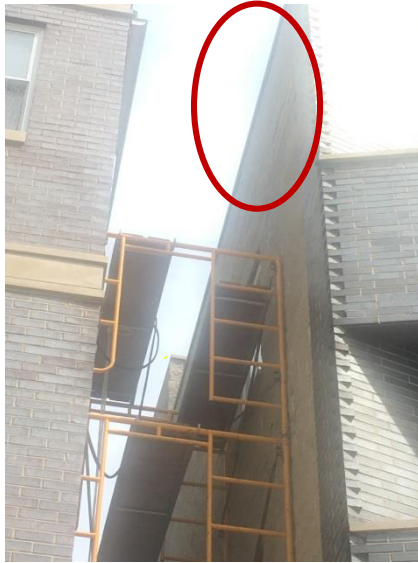
## 3<sup>rd</sup> Floor Leak Location Testing.

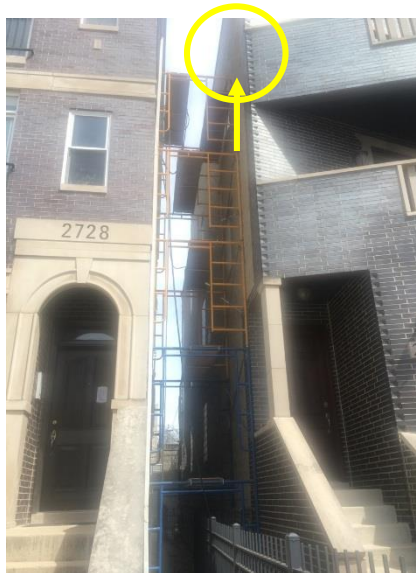
## 3<sup>rd</sup> Floor Leak Location.

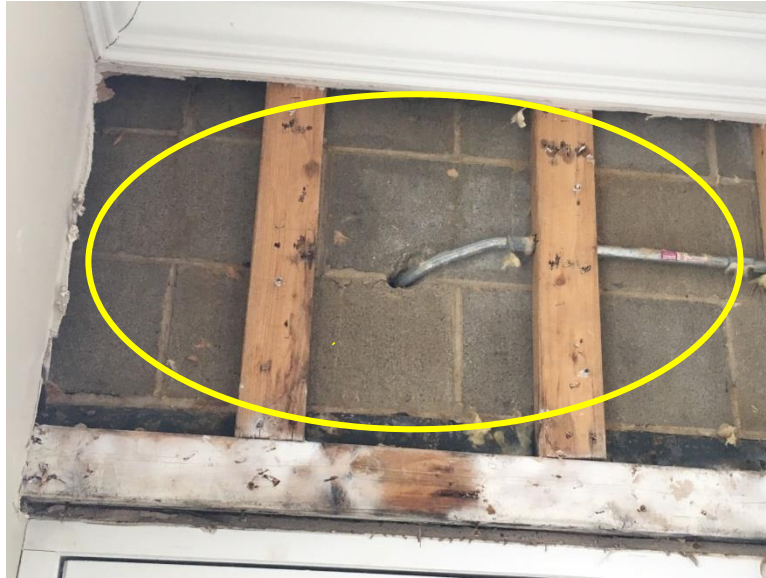
## North Door Leak Testing.

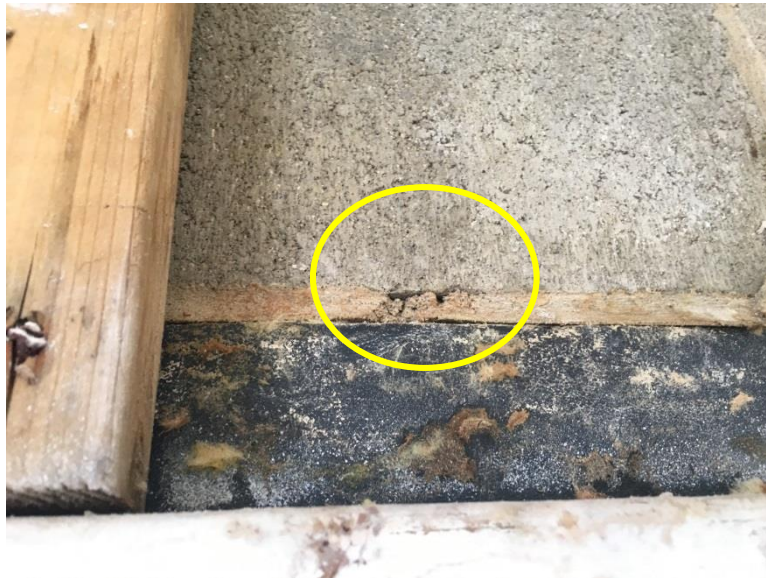
Leak Location North Door.
